# **Intel® Desktop Board D865GRH Specification Update**

Release Date: November 2004

Order Number: C59427-007

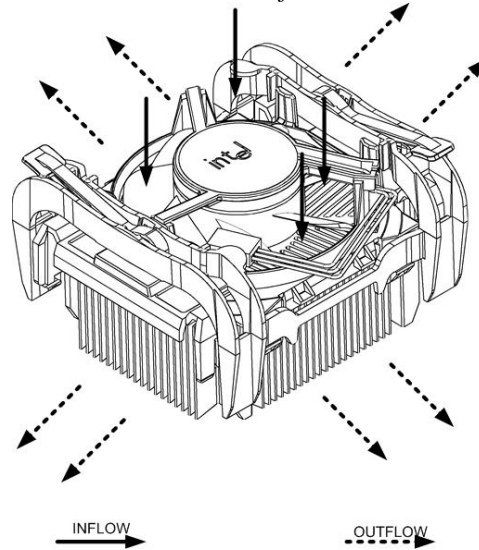
- *A chassis with a maximum internal ambient temperature of 38 Degrees Celsius*
- *A processor heatsink that provides omnidirectional airflow so that air is drawn across the processor voltage regulator area (item A in Figure 26). Figure 25a illustrates an omnidirectional airflow heatsink.*

**Figure 25a. Omnidirectional Airflow Heatsink**
